**ASBESTOS & REGULATED WASTE  
ASSESSMENT REPORT**

**BRIDGE# 5034  
LYONS TOWNSHIP  
LYON COUNTY, MN**

**Lyon County Highway Department  
Suhail Kanwar, P.E., County Engineer**

**September 22, 2011**

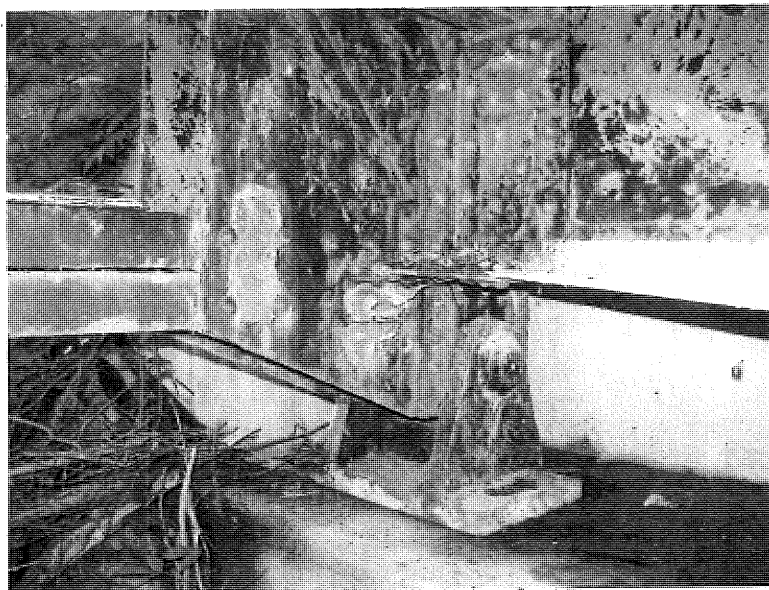
**Sample LP-I was taken from the abutment girder near the pin connection at the SW corner of bridge and indicated a lead presence of 44%.**

**Sample LP-1. Lead paint sample from abutment girder, SW corner of bridge.**

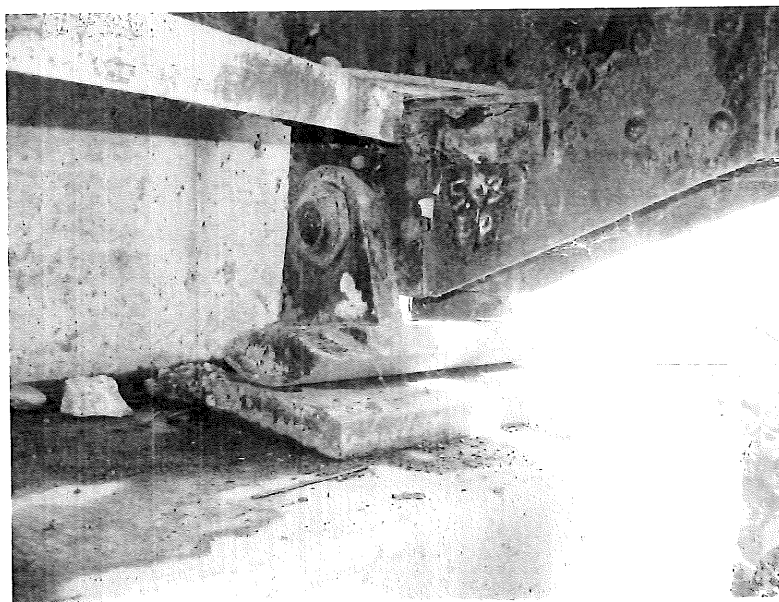
**Sample LP-2 was taken from the stringer beam near the rocker pin connection at the NE corner of bridge and indicated a lead presence of 38%.**

**Sample LP-2. Lead paint sample from stringer beam at NE corner of bridge.**

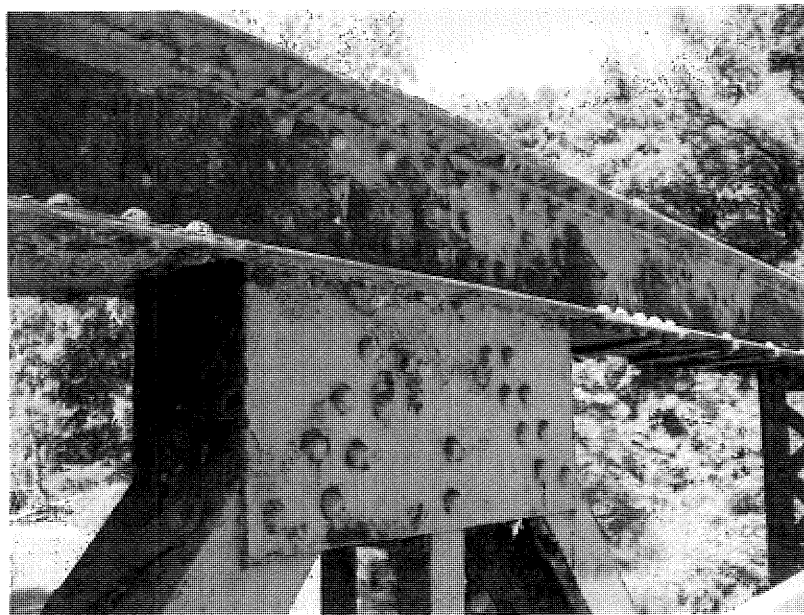
**Sample LP-3 was taken from the truss member, downstream side of bridge at midspan and indicated a lead presence of 42%.**

**Sample LP-3. Lead paint sample from truss member.  
Downstream side of bridge at midspan.**

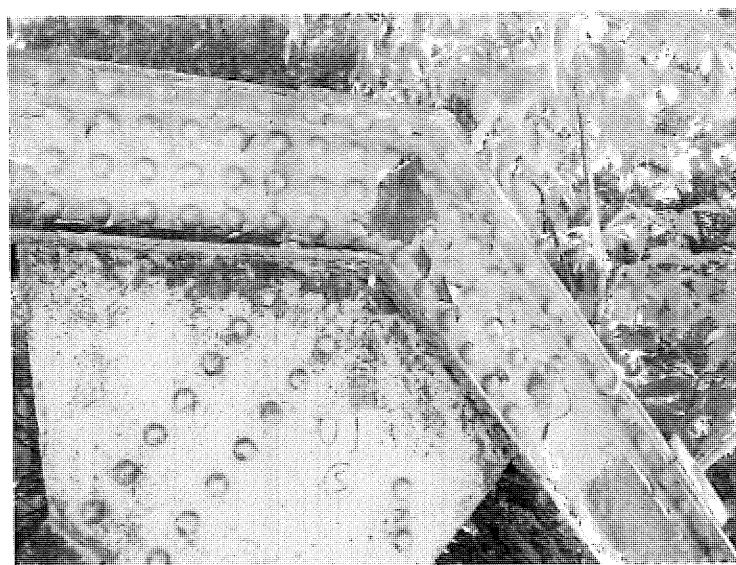
**Sample LP-4 was taken from the gusset plate at the SW corner of bridge and indicated a lead presence of 42%.**

**Sample LP-4. Lead paint sample from gusset plate at SW corner of bridge.**

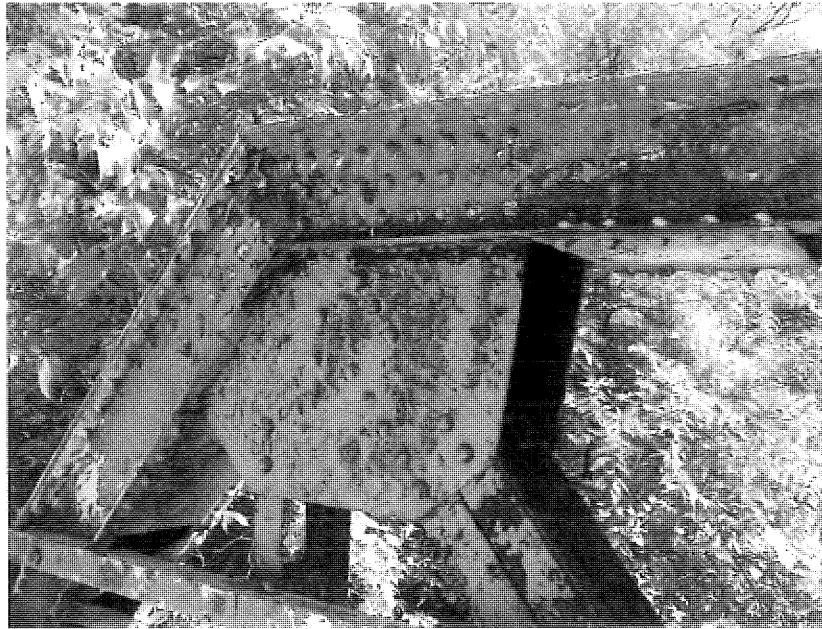
**Sample LP-5 was taken the gusset plate at the NE corner of bridge and indicated a lead presence of 42%.**

**Sample LP-5. Lead paint sample from gusset plate at NE corner of bridge.**

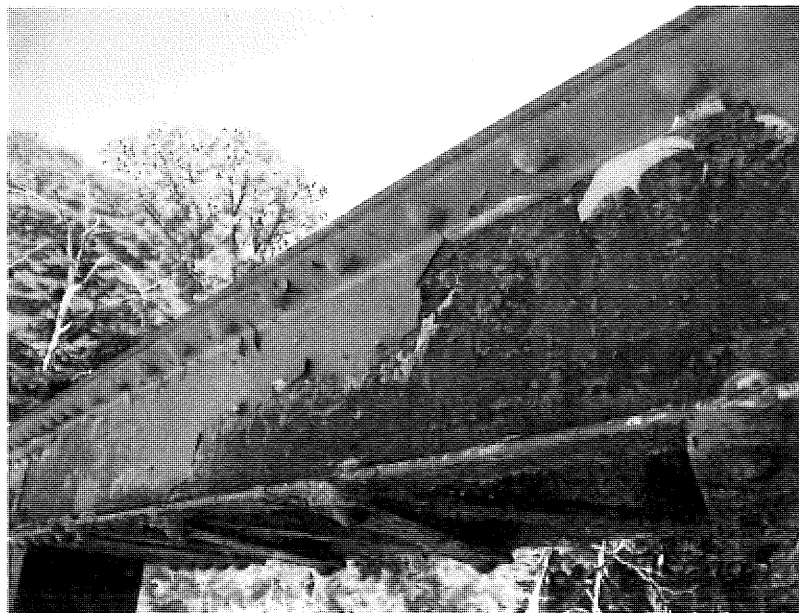
**Sample LP-6 was taken from the top member of truss structure, South side of bridge at midspan and indicated a lead presence of 39%.**

**Sample LP-6. Lead paint sample from top truss member, South side at midspan.**

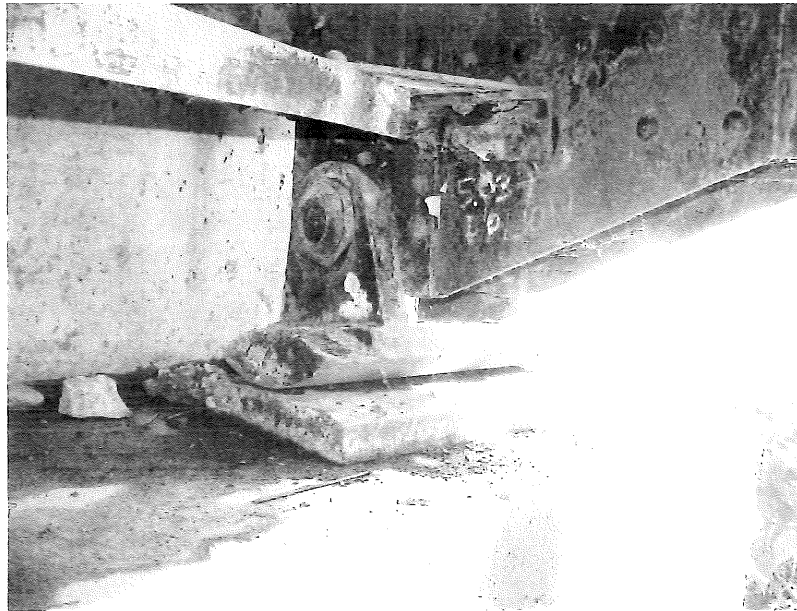
**SE corner of abutment showing rocker connection and C-I-P concrete abutment.**

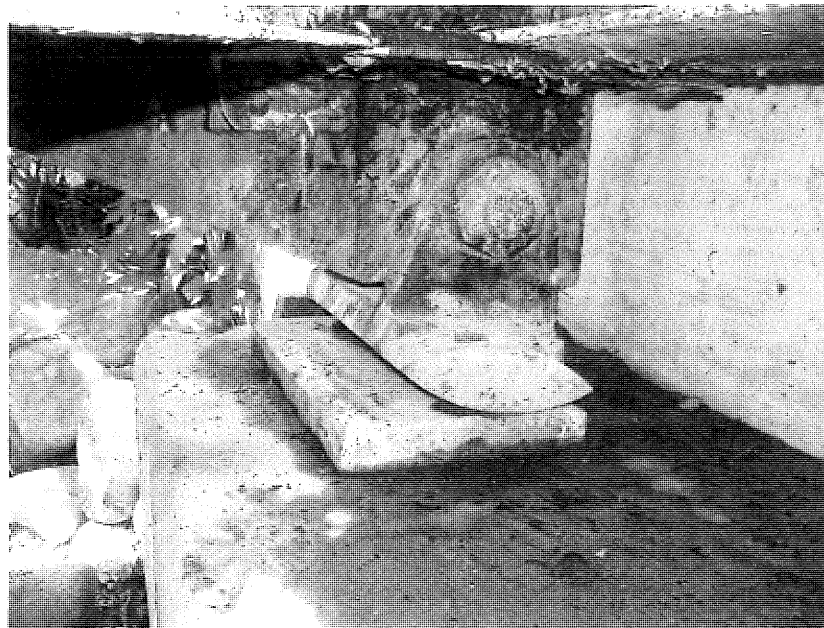
**SW corner of abutment showing rocker connection and P-I-C concrete abutment.**

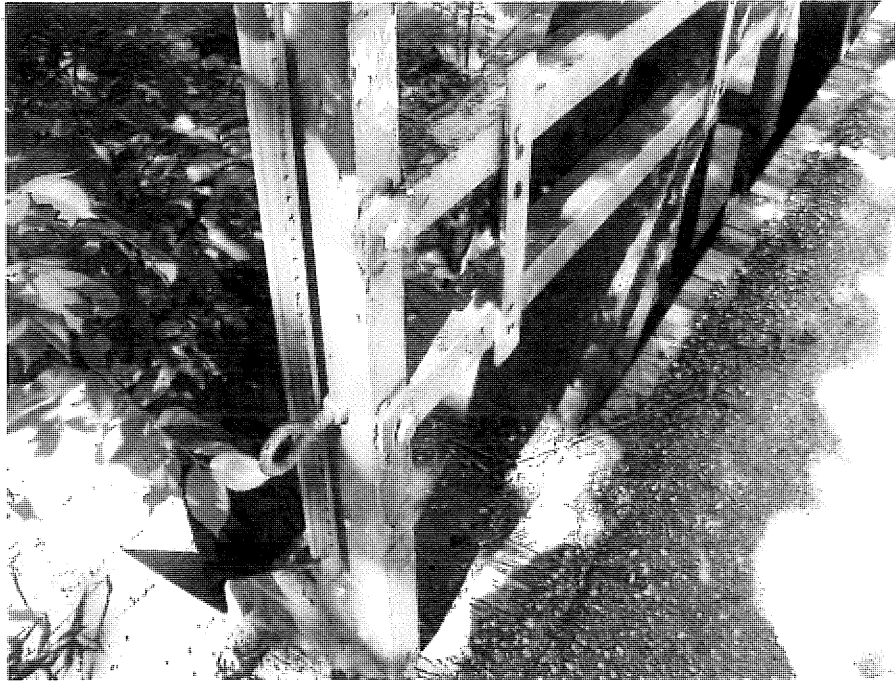
**Steel angle iron railing affixed to truss members.**
