**ASBESTOS & REGULATED WASTE
ASSESSMENT REPORT**

**BRIDGE# 5101A
LYONS TOWNSHIP
LYON COUNTY, MN**

September 22, 2011

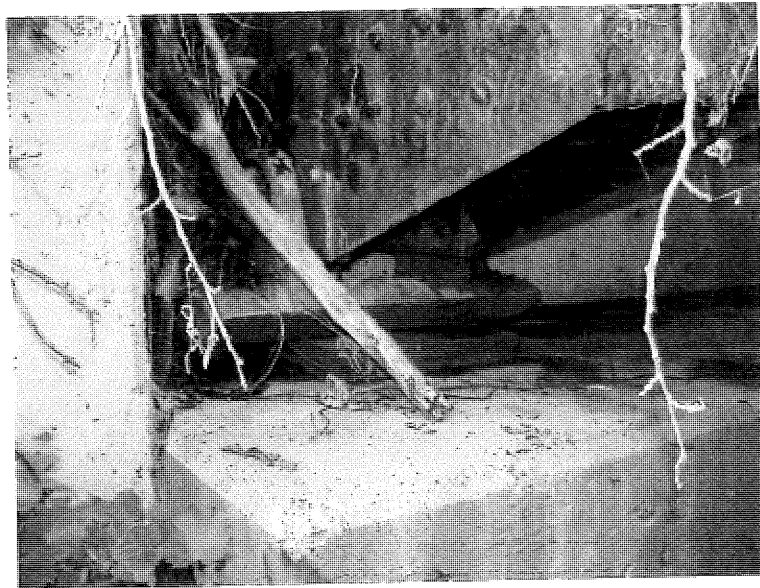
Sample LP-1 was taken from the abutment girder near the rocker pin assembly at the SW corner of bridge and indicated a lead presence of 30%.

**Sample LP-1. Lead paint sample from abutment girder near rocker pin assembly.
SW corner of bridge.**

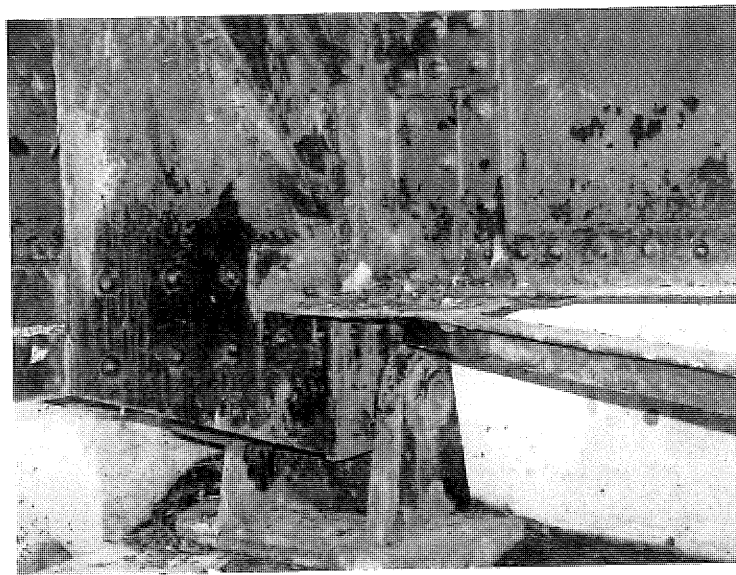
Sample LP-2 was taken from the pin assembly at the SE corner of bridge and indicated a lead presence of 17%.

Sample LP-2. Lead paint sample from pin assembly at the SE corner of bridge.

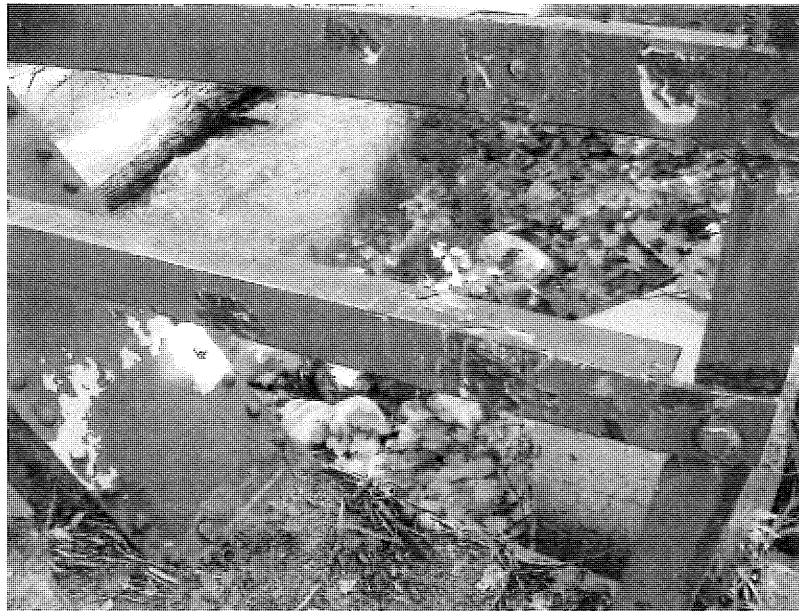
Sample LP-3 was taken from the railing at the SW corner of bridge and indicated a lead presence of 27%.

Sample LP-3. Lead paint sample from railing at SW corner of bridge.

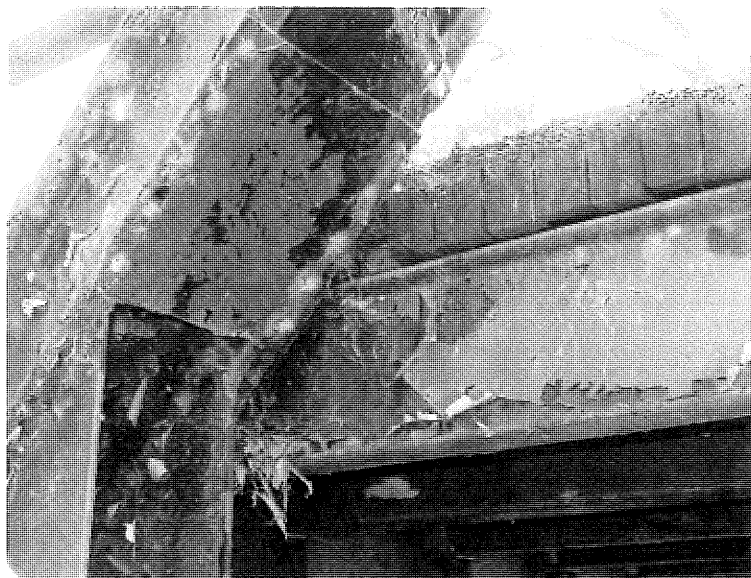
Sample LP-4 was taken from the gusset plate assembly at the NE corner of bridge and indicated a lead presence of 40%.

Sample LP-4. Lead paint sample from gusset plate at NE corner of bridge.

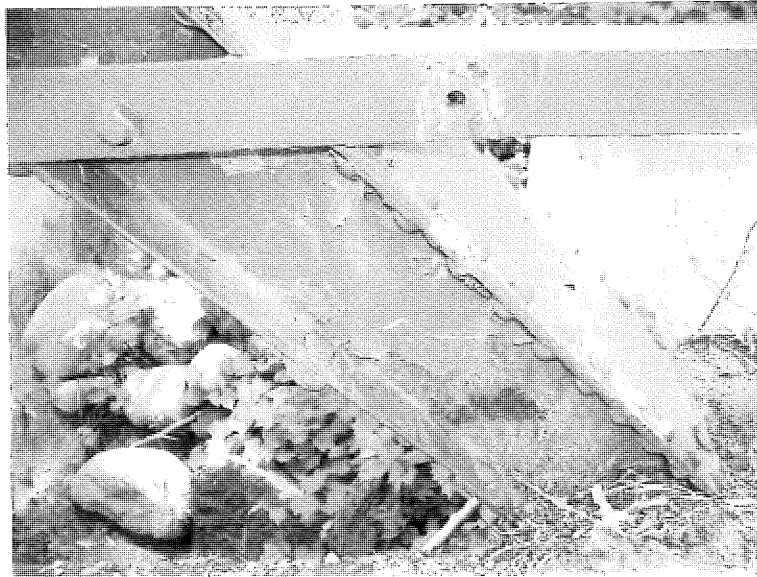
Sample LP-5 was taken the truss member at the NW corner of bridge and indicated a lead presence of 37%.

Sample LP-5. Lead paint sample from truss member at NW corner of bridge.

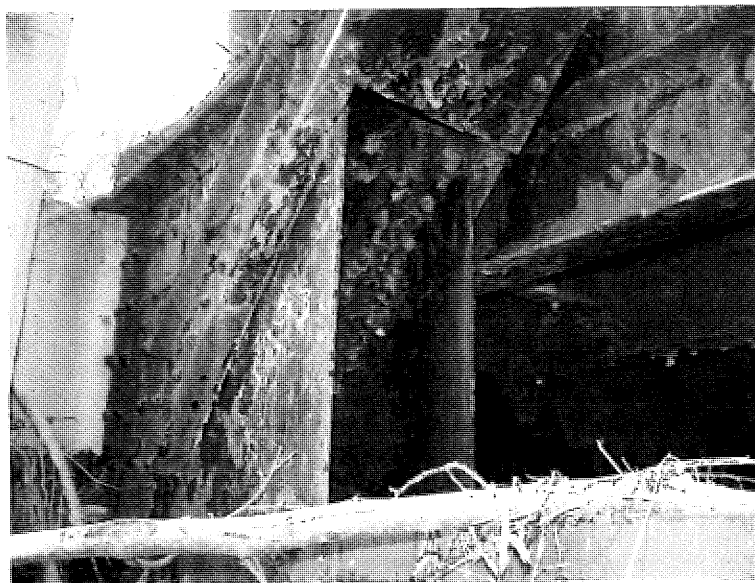
Sample LP-6 was taken from the truss member at the NE corner of bridge and indicated a lead presence of 29%.

Sample LP-6. Lead paint sample from truss member at NE corner of bridge.

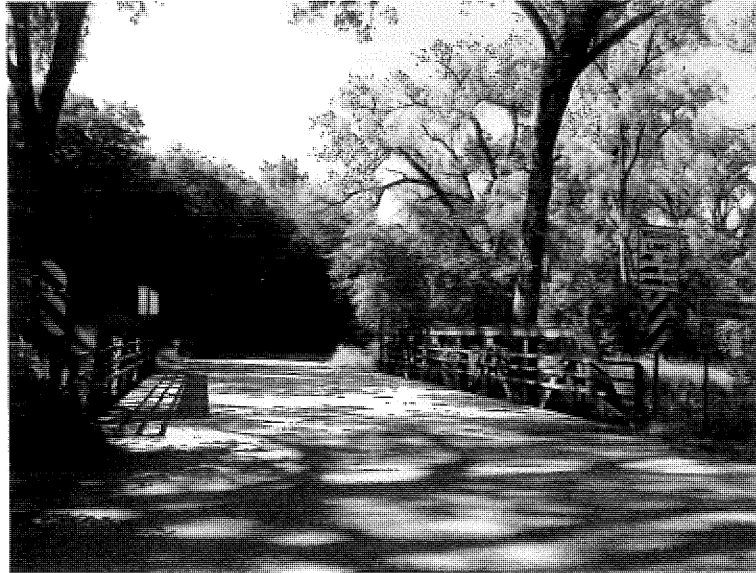
South approach to bridge looking North.

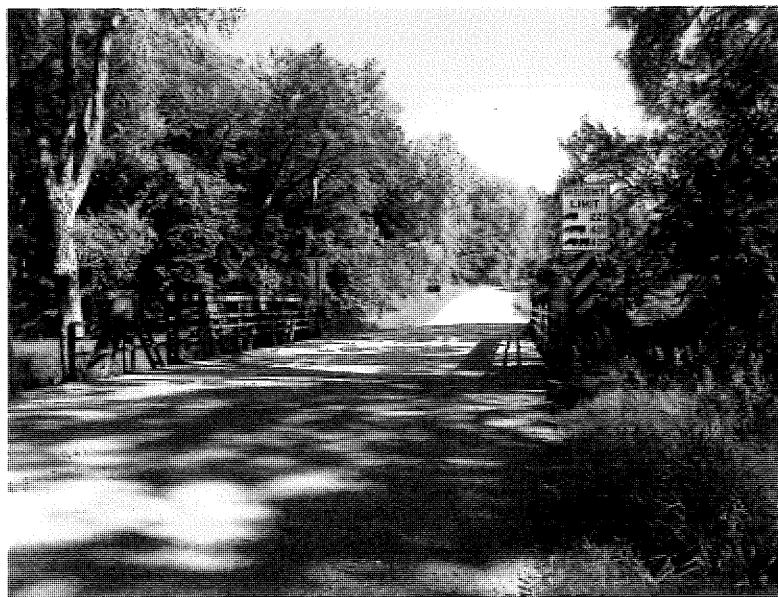
North approach to bridge looking South.

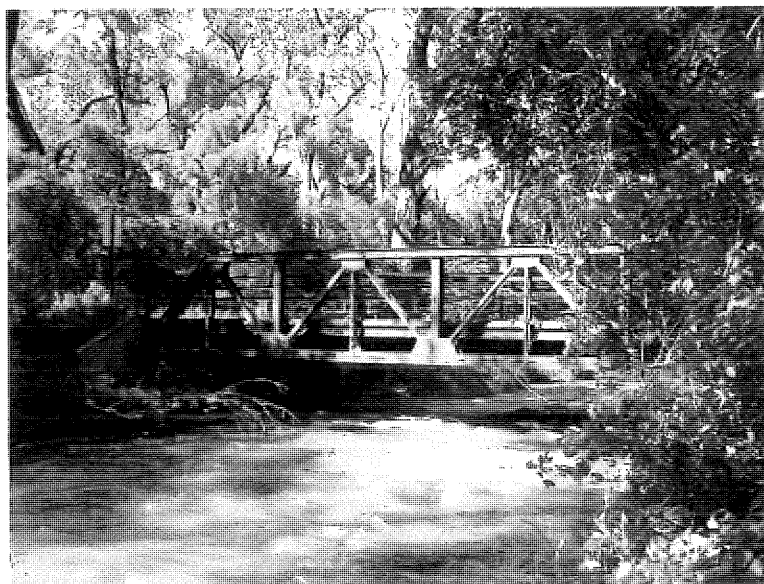
West side of bridge.

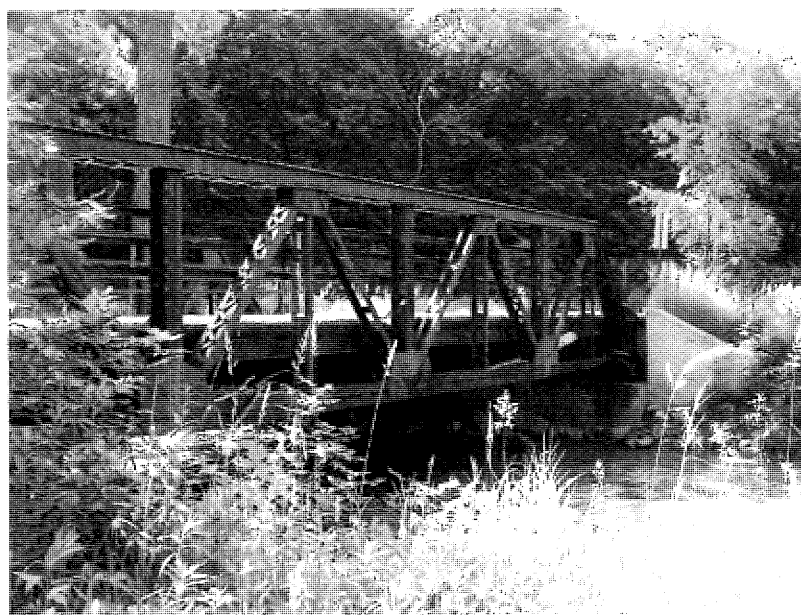
East side of bridge.

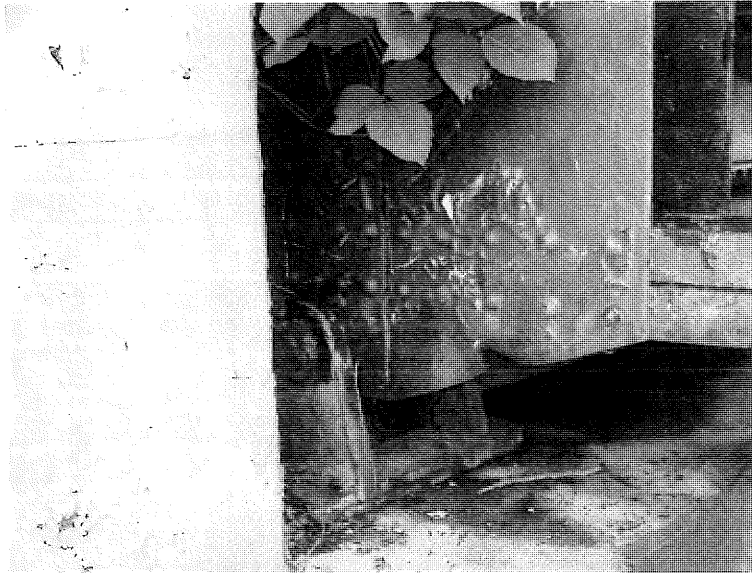
SE corner of abutment showing pin connection and C-I-P concrete abutment.

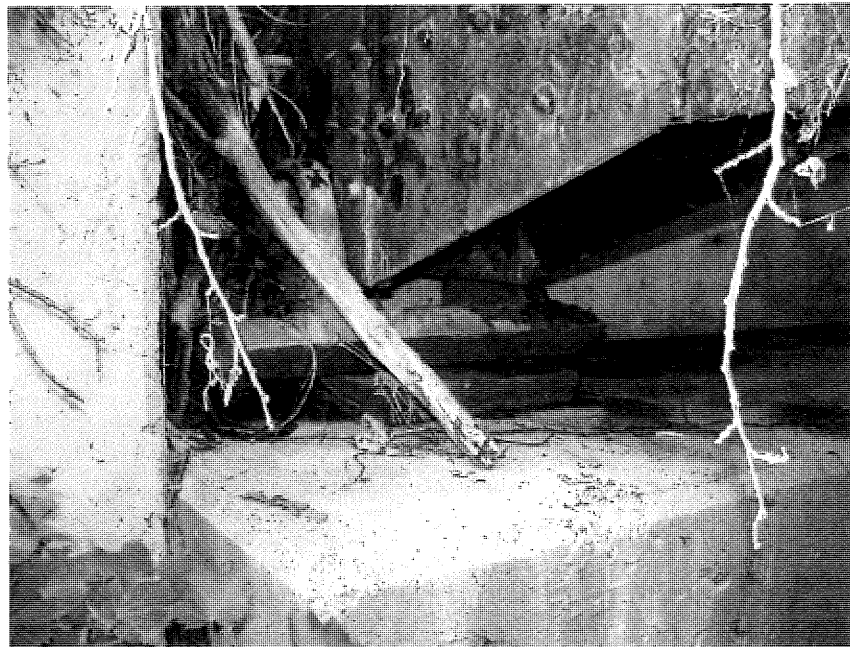
SW corner of abutment showing rocker connection and P-I-C concrete abutment.

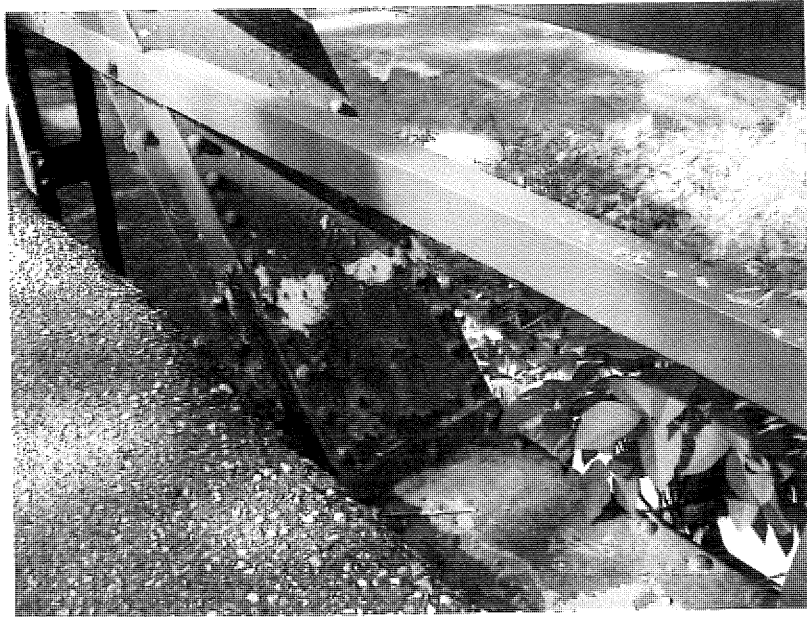
Steel angle iron railing affixed to truss members.
