**ASBESTOS & REGULATED WASTE
ASSESSMENT REPORT**

**BRIDGE# R0122
LYND TOWNSHIP
LYON COUNTY, MN**

**Lyon County Highway Department
Suhail Kanwar, P.E., County Engineer**

September 22, 2011

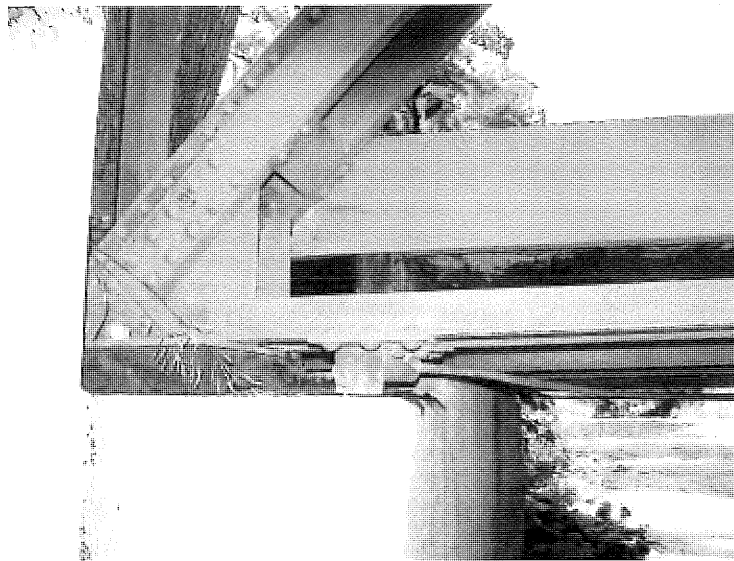
Sample LP-1 was taken from the truss member at lower chord gusset plate. NE corner of bridge and indicated a lead concentration of 8.3%.

**Sample LP-1. Lead paint sample from truss member at lower chord gusset plate.
NE corner of bridge.**

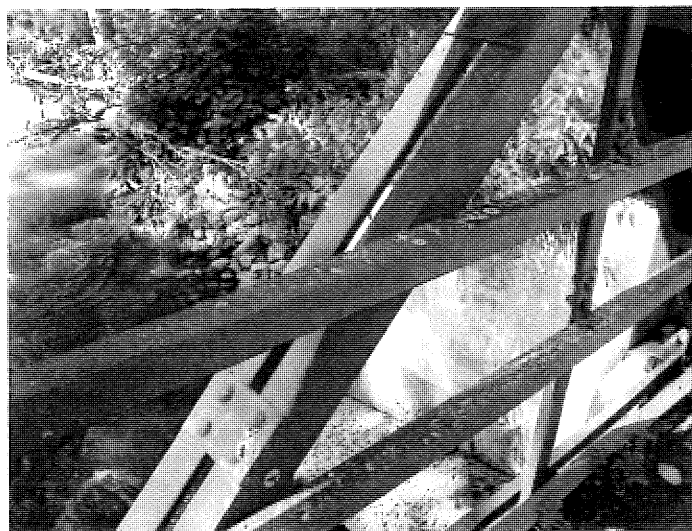
Sample LP-2 was taken from the bridge rail on upstream side, North end of bridge and indicated a lead concentration of 0.070%.

Sample LP-2. Lead paint sample from bridge rail on upstream side, North end of bridge.

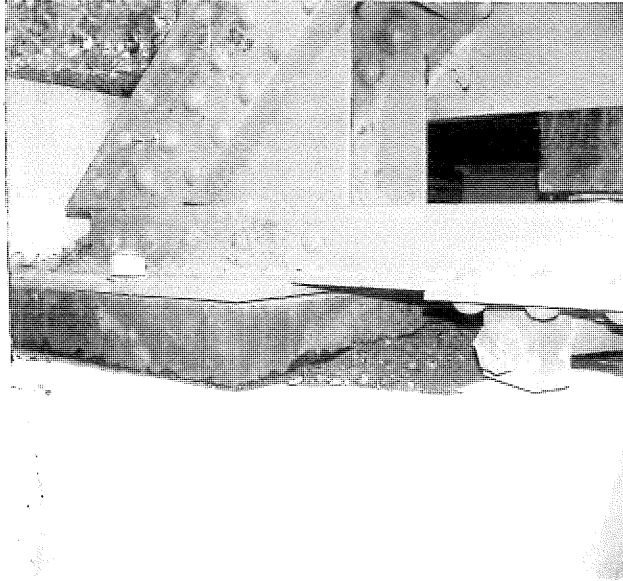
Sample LP-3 was taken from the truss member at the lower chord gusset plate, SW corner of bridge and indicated a lead concentration of 0.049%.

**Sample LP-3. Lead paint sample from truss member at lower chord gusset plate.
SW corner of bridge.**

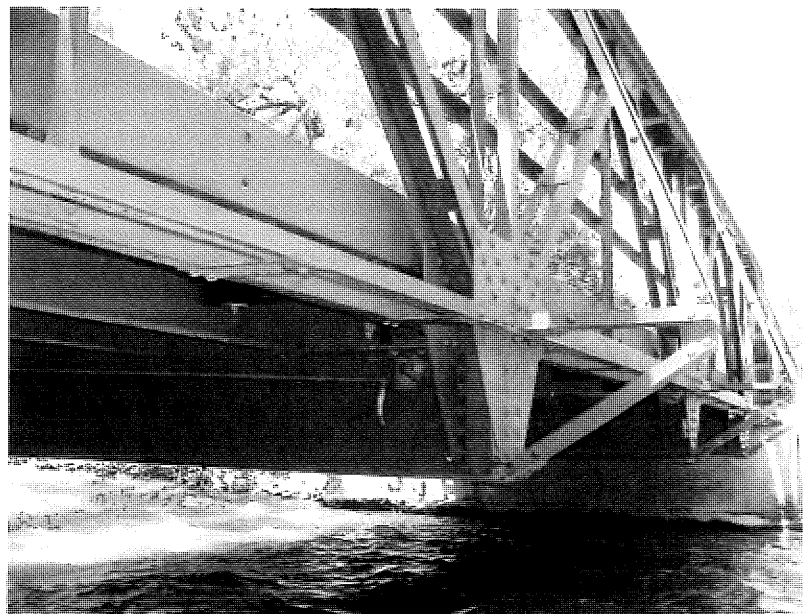
Sample LP-4 was taken from the downstream fascia beam at the South end of bridge and indicated a lead concentration of 0.33%.

Sample LP-4. Lead paint sample from downstream fascia beam at South end of structure.

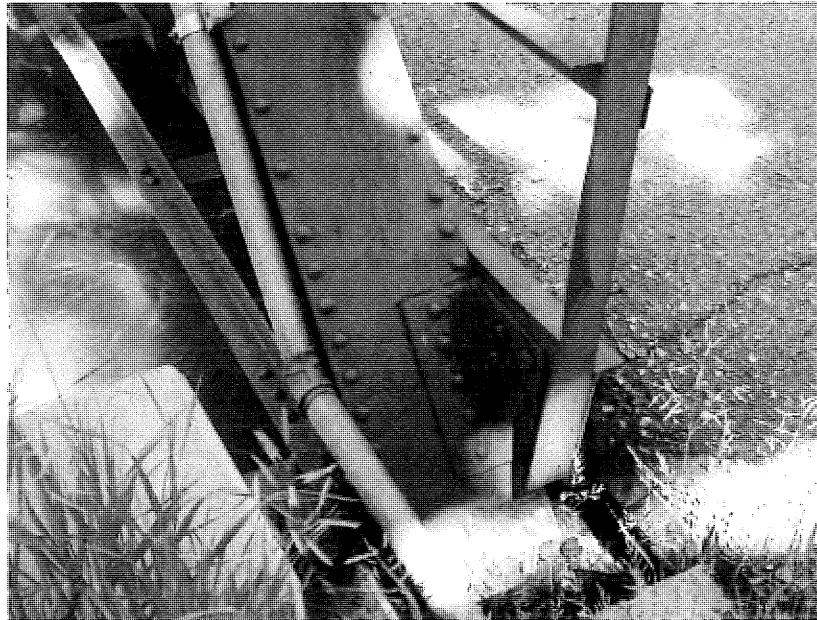
2.3.8 There is a possible utility in a conduit on the upstream side of bridge. Type and owner unknown. Conduit appears to be steel pipe.

Possible utilities in conduit on upstream side of bridge. Owner unknown.

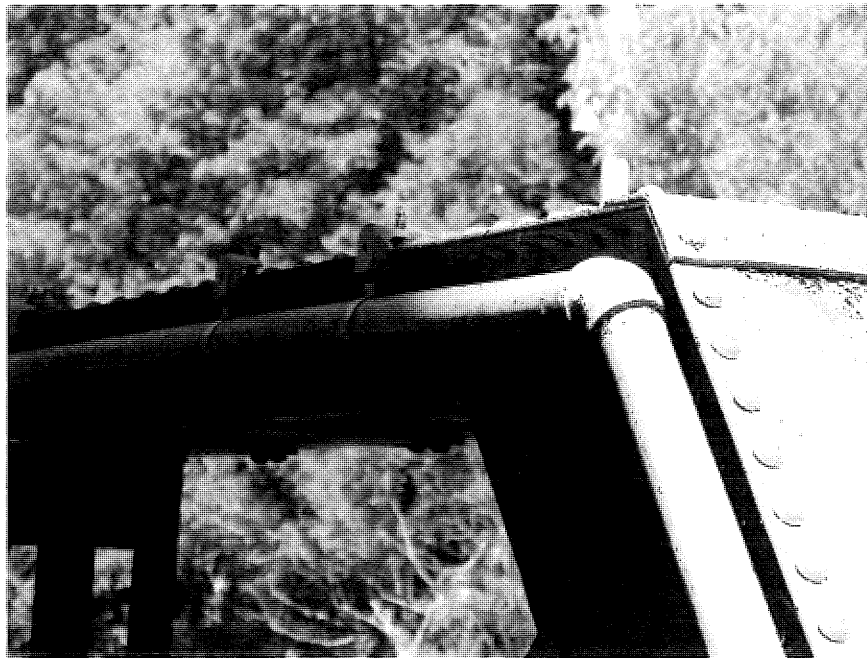
Conduit on upstream side of bridge.

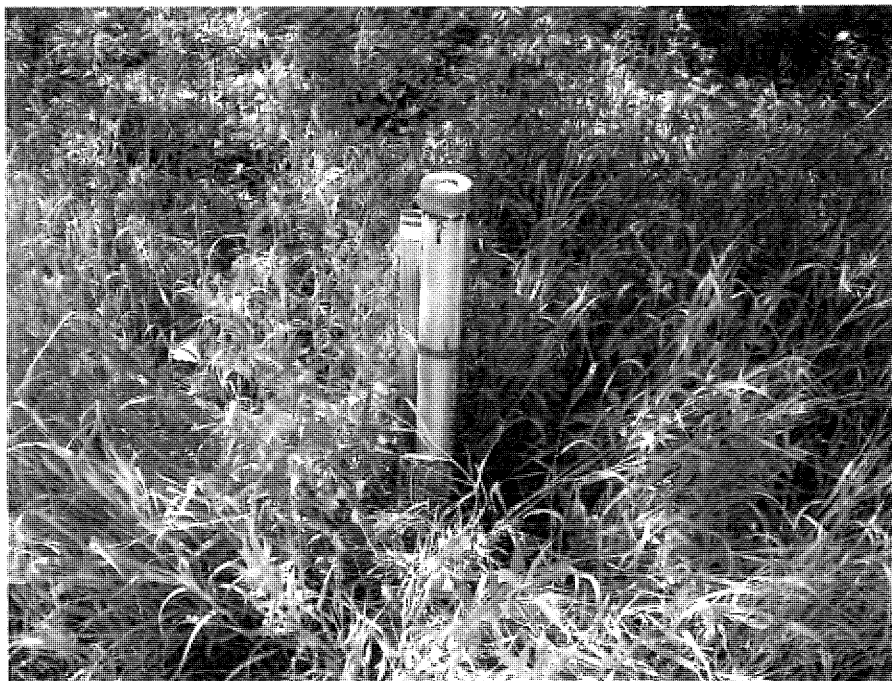
2.3.9 There is a stand pipe on the West R/W line approximately 100' North of the bridge. Function and owner unknown.

**Stand pipe installation on West R/W line approximately 100' North of bridge.
Owner and function unknown.**
